**WEDGEWIRE SCREEN SITE-SPECIFIC STUDY
ENGINEERING EVALUATION**

**GSP SCHILLER LLC – SCHILLER STATION
PORTSMOUTH, NEW HAMPSHIRE**

Submitted by:
Enercon Services, Inc.
7677 Oakport Street, #950
Oakland, CA 94621
July 28, 2020

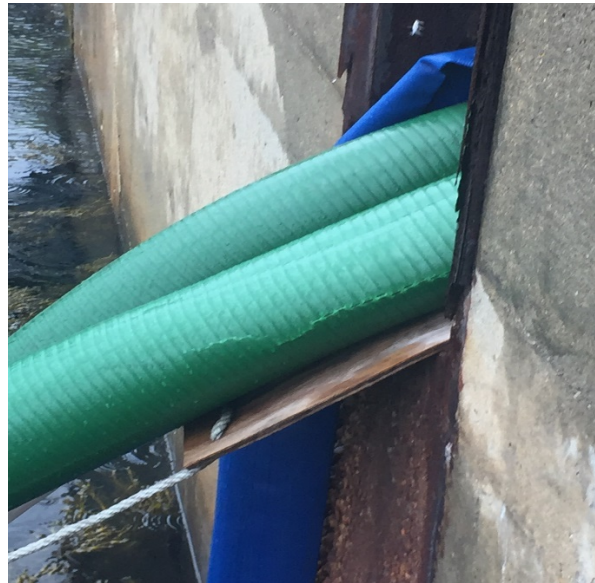
Figure B-1: Fractured North Intake Hose

This addendum was generated following an abnormal operating event that occurred on August 31, 2019 and September 1, 2019. During the event, a fluctuating vacuum gauge reading indicating a loss of suction pressure caused a safety trip, turning off both of the sampling pumps. This led to a backflushing of the screens and a visual dive inspection of the pilot wedgewire screens. This addendum details the findings of the inspection and the actions taken as a result of the loss of suction pressure.

was constructed from a spliced section of hose of the same specification.

Following the inspection and repairs, the north intake pump was successfully restarted, regular operations resumed, and scheduled sample collections were continued. Backflushing and inspections continued on an as-needed basis.

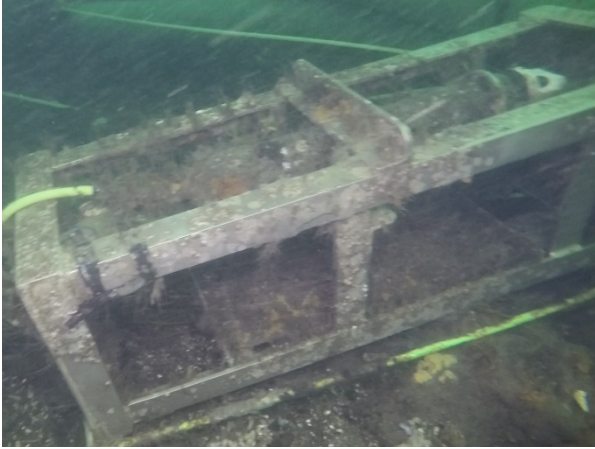
North ADCP Against Suction Hose

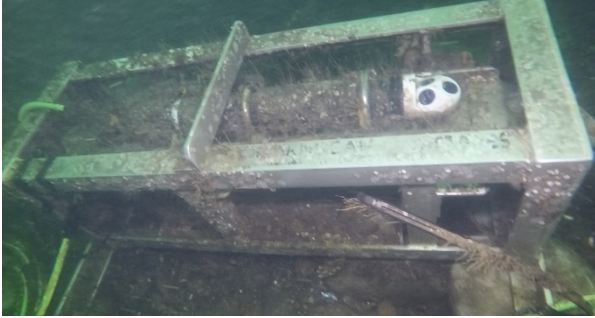
North ADCP Returned to Location

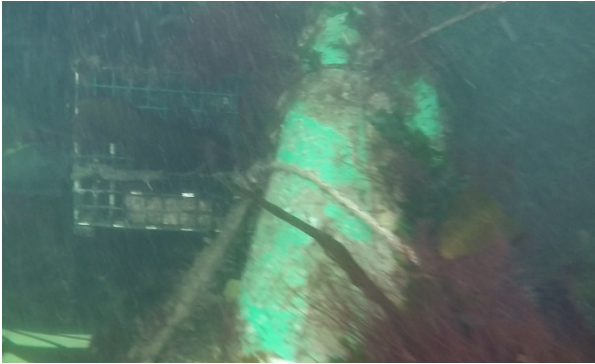
Lobster Trap Against Suction Hose

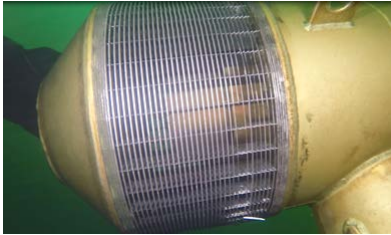
October 1, 2019	December 7, 2019	On Shore January 23, 2020
Upstream 3.0 mm Wedgewire Screen River Facing Damage

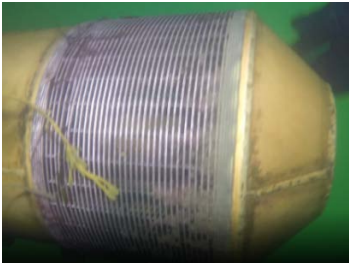
Downstream 3.0 mm Wedgewire Screen River Facing Damage

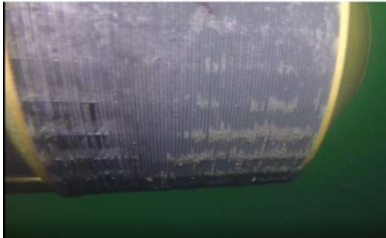
Downstream 0.8 mm Wedgewire Screen River Facing Damage

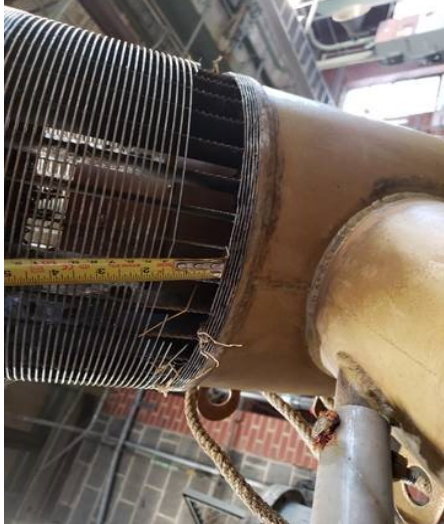
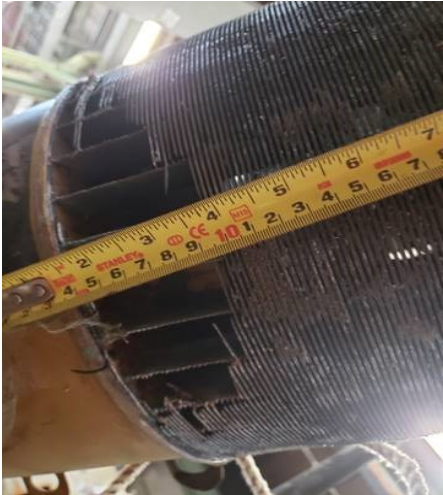
Table E-8: Imagery of Measured Damage on Pilot Wedgewire Screens

3.0 mm Screen Damage	0.8 mm Screen Damage
